# The 1983 and 2003 Blackouts in Sweden

Nordic Electric Power System Seminar Chalmers  
November 09, 2023

Daniel Karlsson, DNV  
Adjunct Professor, Chalmers

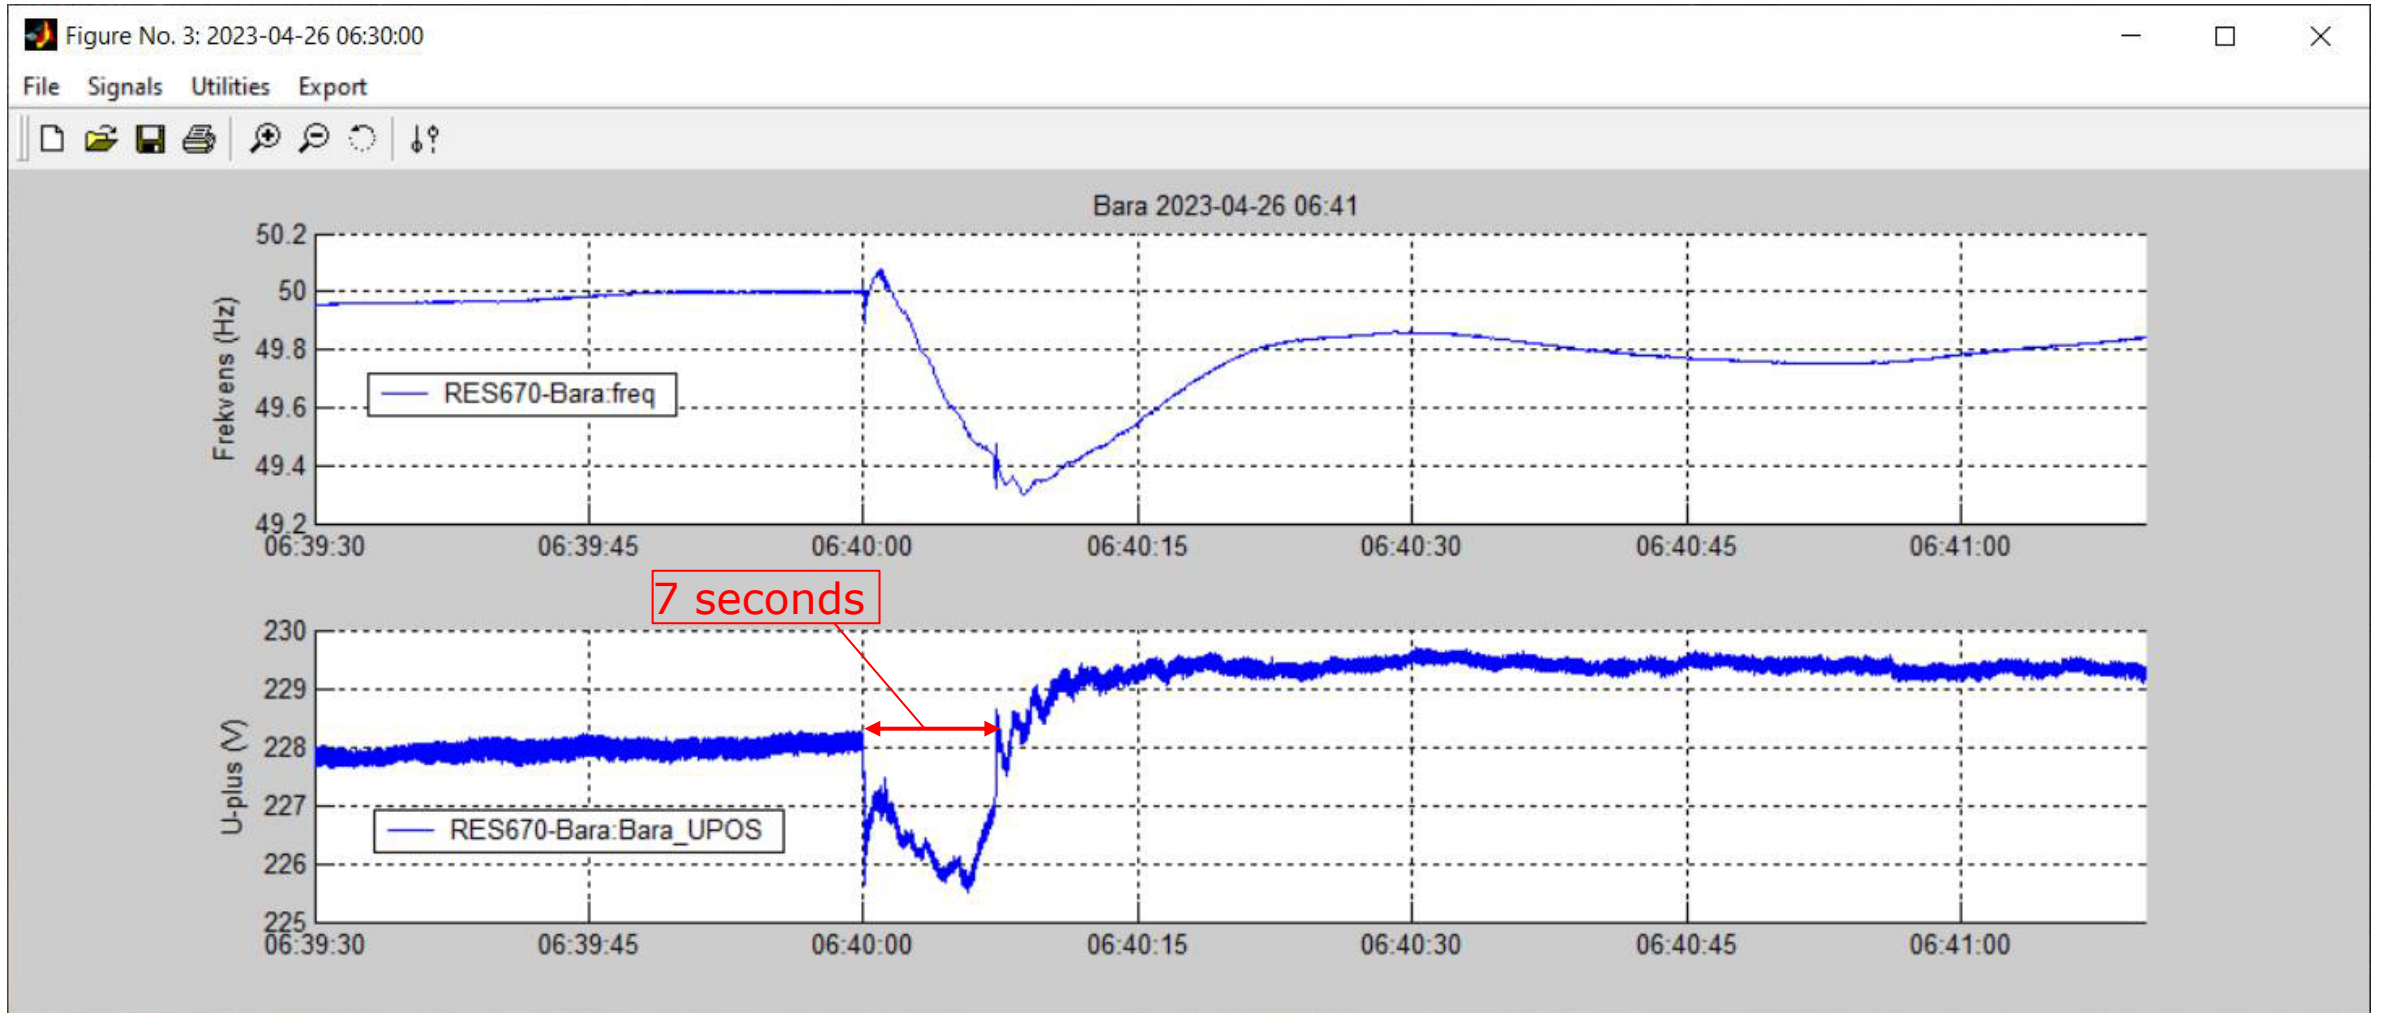
# Hagby 220 kV fault – First notice – A closer look

- If you know what you are looking for – You can see the 7 seconds!

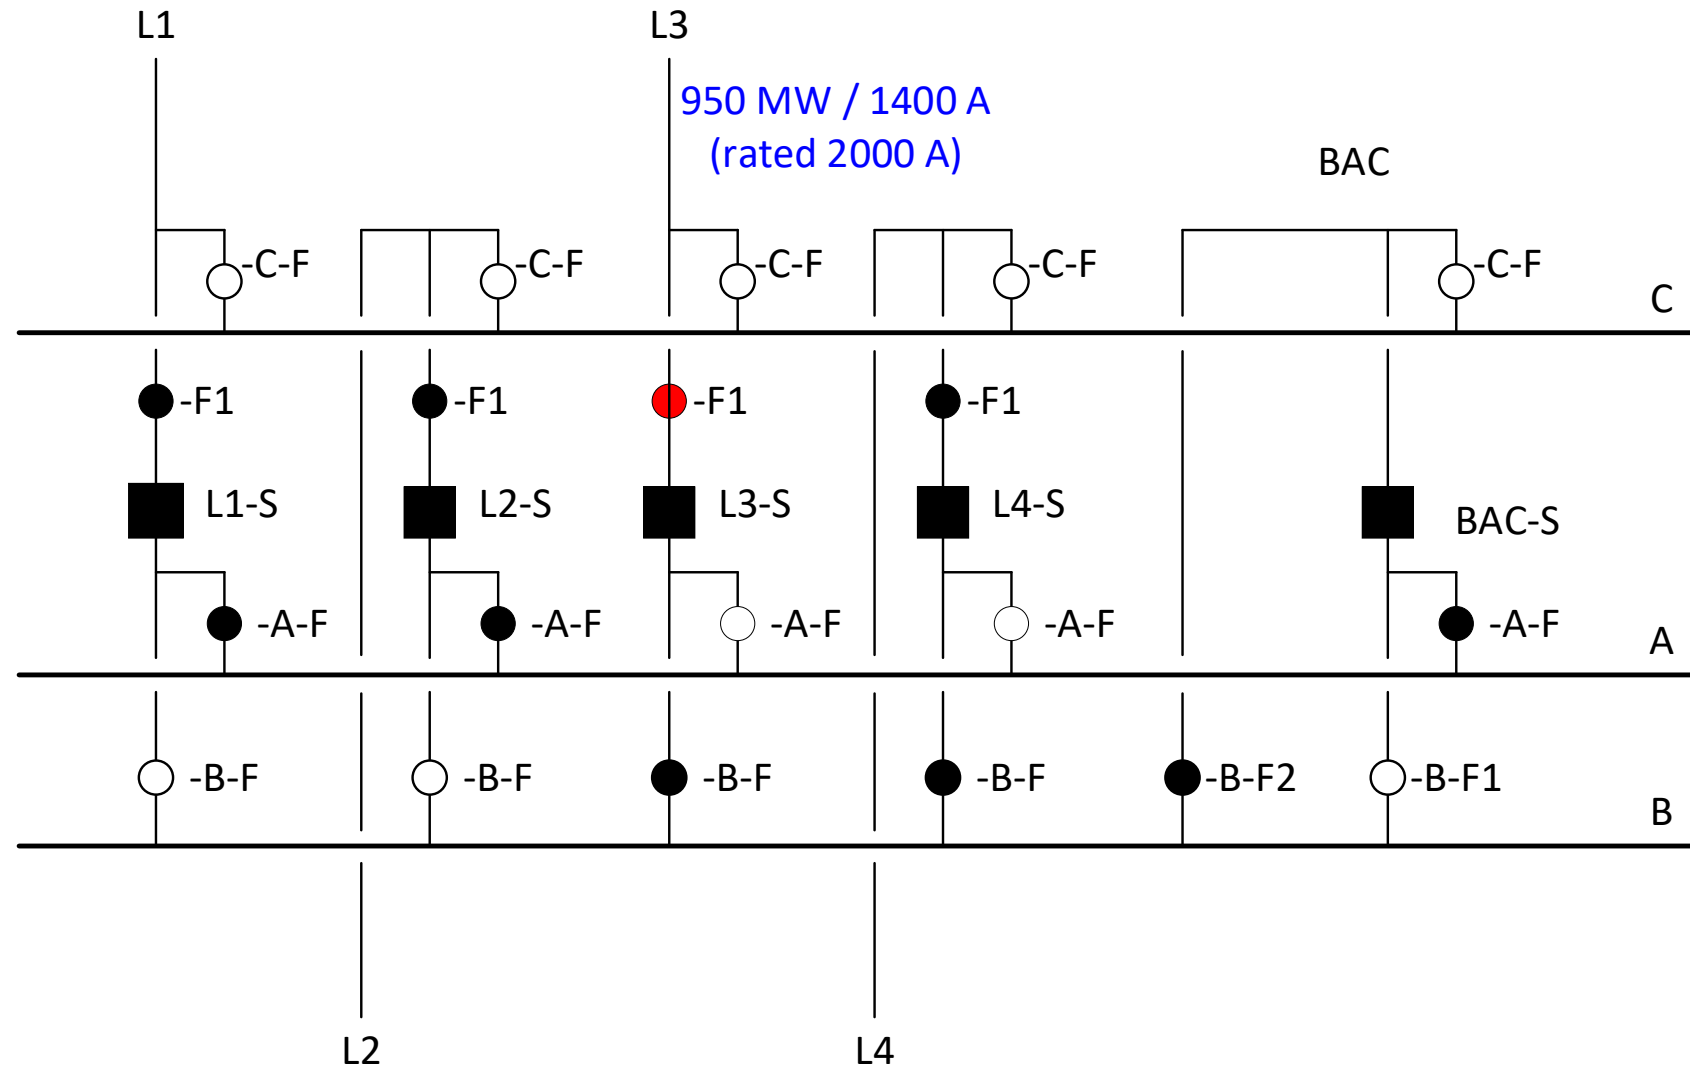
## 12:25 – Overheated disconnecter L3-F1 observed

- Overheated due to high resistance – load current less than rated
- Agreed with the control room to immediately take the disconnecter out of operation
- Decided to use the backup breaker and firmly connect bus A and bus B

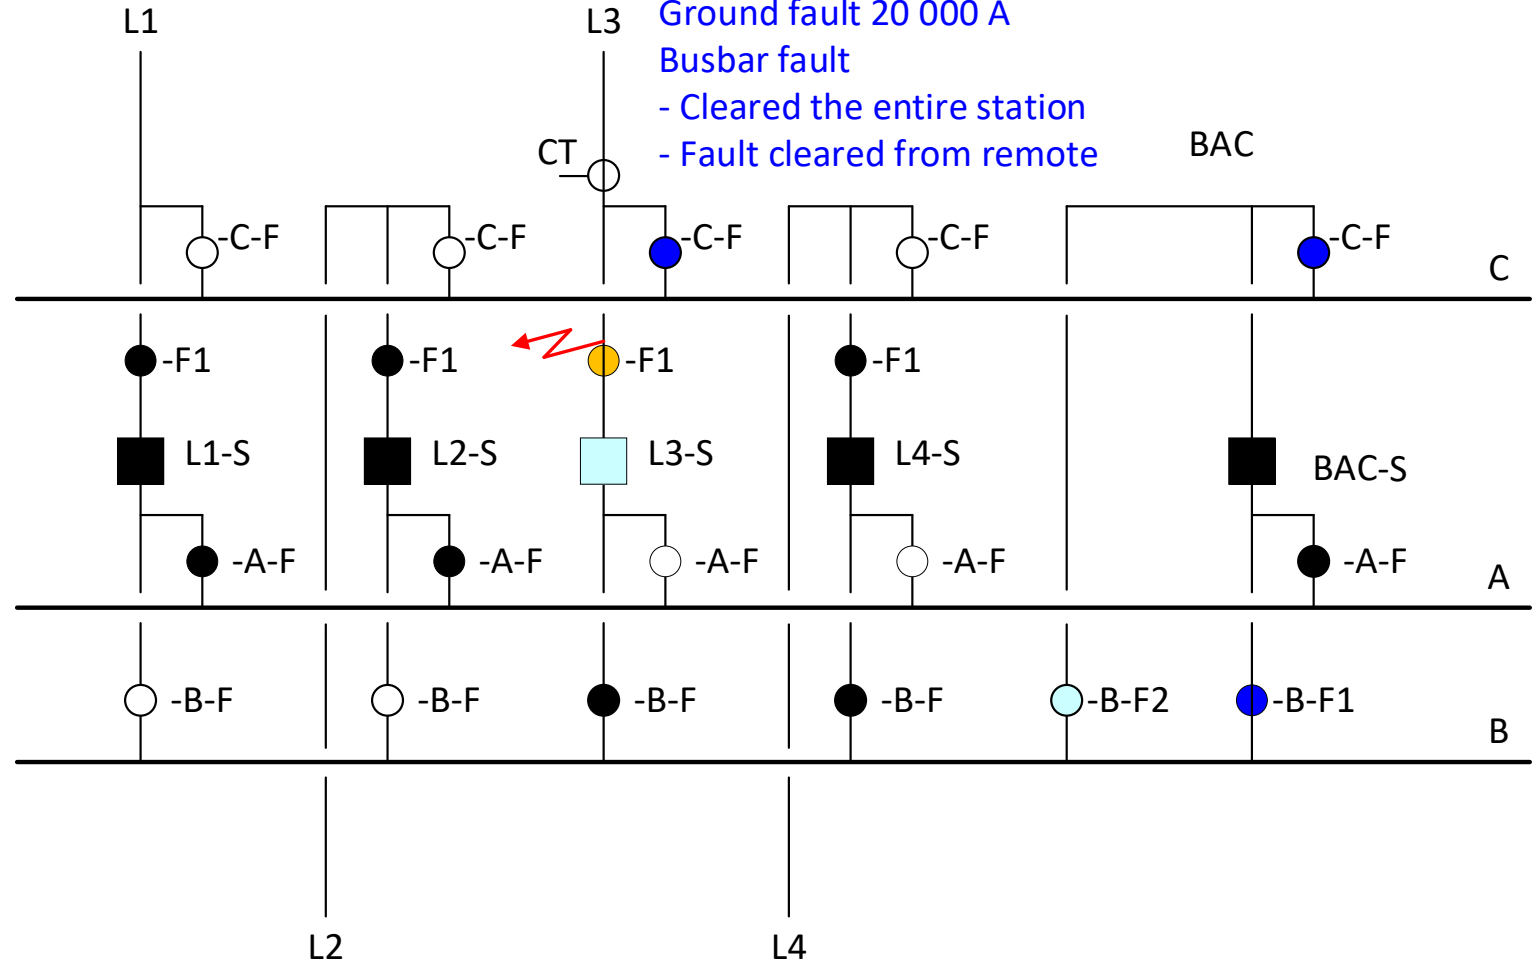
# 12:57 – The line end / busbar earthfault

- The final stage in the standardized switching sequence:
  - Open the disconnector L3-F1
  - As the disconnector was damaged, it fell apart and caused an earthfault
  - Busbar protection cleared in 3+40 ms (RADSS – Not digital...)

Open L3-F1 --- Why?  
 Disconnecter fell to ground  
 Ground fault 20 000 A  
 Busbar fault  
 - Cleared the entire station  
 - Fault cleared from remote

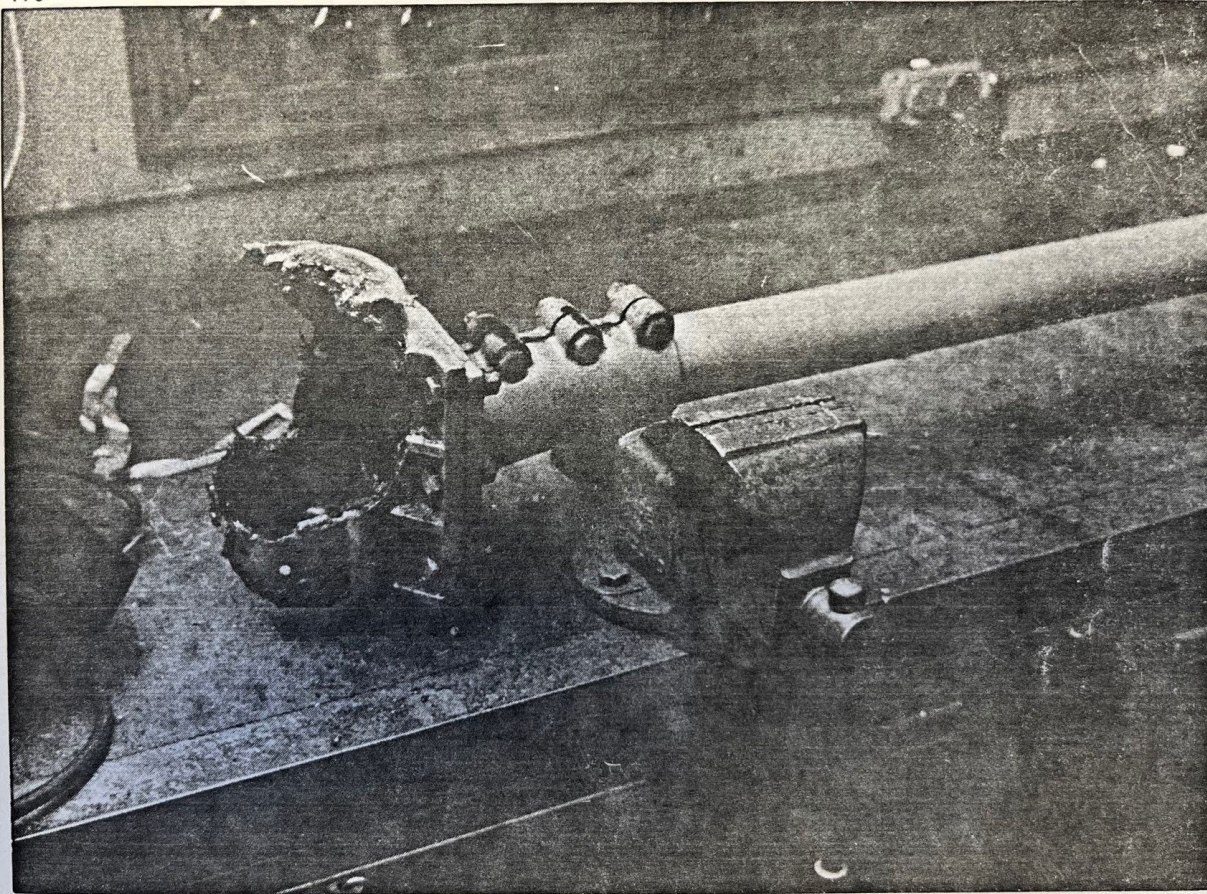
# The damaged disconnecter in Hamra

Här är den: den trasiga frånskiljaren som satt i ställverket vid Hamra transformatorstation utanför Enköping. Överhettning har uppgivits som fel... På sid 15: driftchefen på Hamra, Hilding Ädel. Foto: Weine Lexius, Expressen.

- There is a lot to learn from the history
- Proper – time stamped - recordings is of utmost importance for reliable disturbance investigations
- Disconnectors are critical sources of fault – Disconnectors are being removed
- ABC-switchgears are redesigned to double-bus double-breaker design
- Maximum mesh of the system can be questioned
- We are facing a transition towards more and more inverter connected weather dependant generation, which adds new types of “disturbances”, e.g. due to unexpected shift in weather conditions
- There is a great potential for protection systems for the southern part of Sweden based on PMUs and communication.

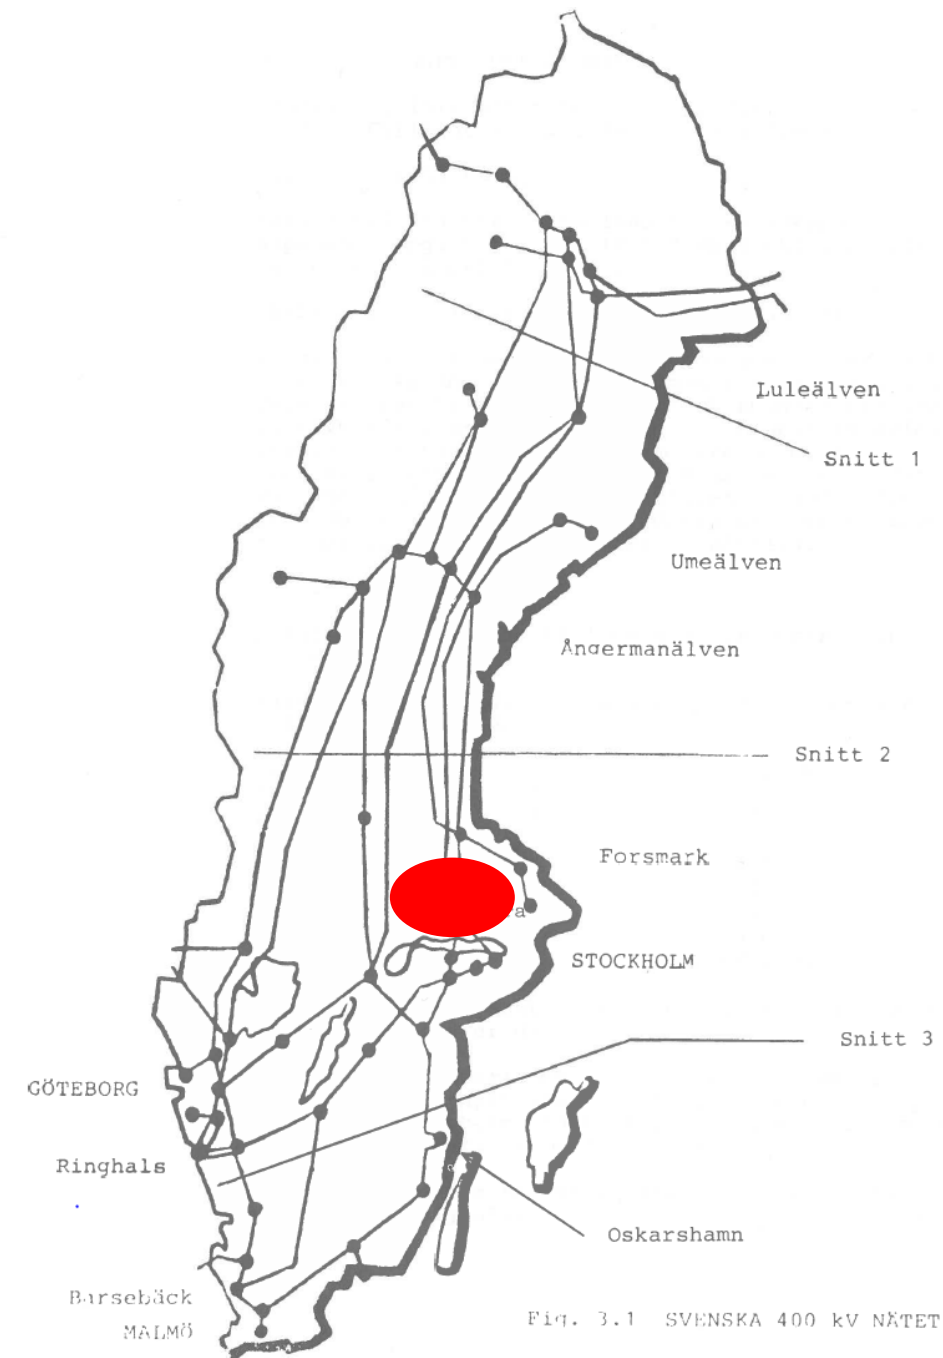
## 12:57 – A big hole in the transmission network – No loss of generation

- 2 connections North-South lost
- Important infeed to Stockholm area lost
- No loss of generation
- No change in frequency
- Significantly reduced voltage in mid Sweden
- 6 seconds after the earth-fault a 220 kV line feeding Stockholm tripped due to overload (underimpedance Zone 3)
- Voltages in Southern Sweden kept up by the nuclear generation in Ringhals, Oskarshamn and Barsebäck
- Subsequent voltage reduction in Southern Sweden due to tap-changer stepping and load recovery

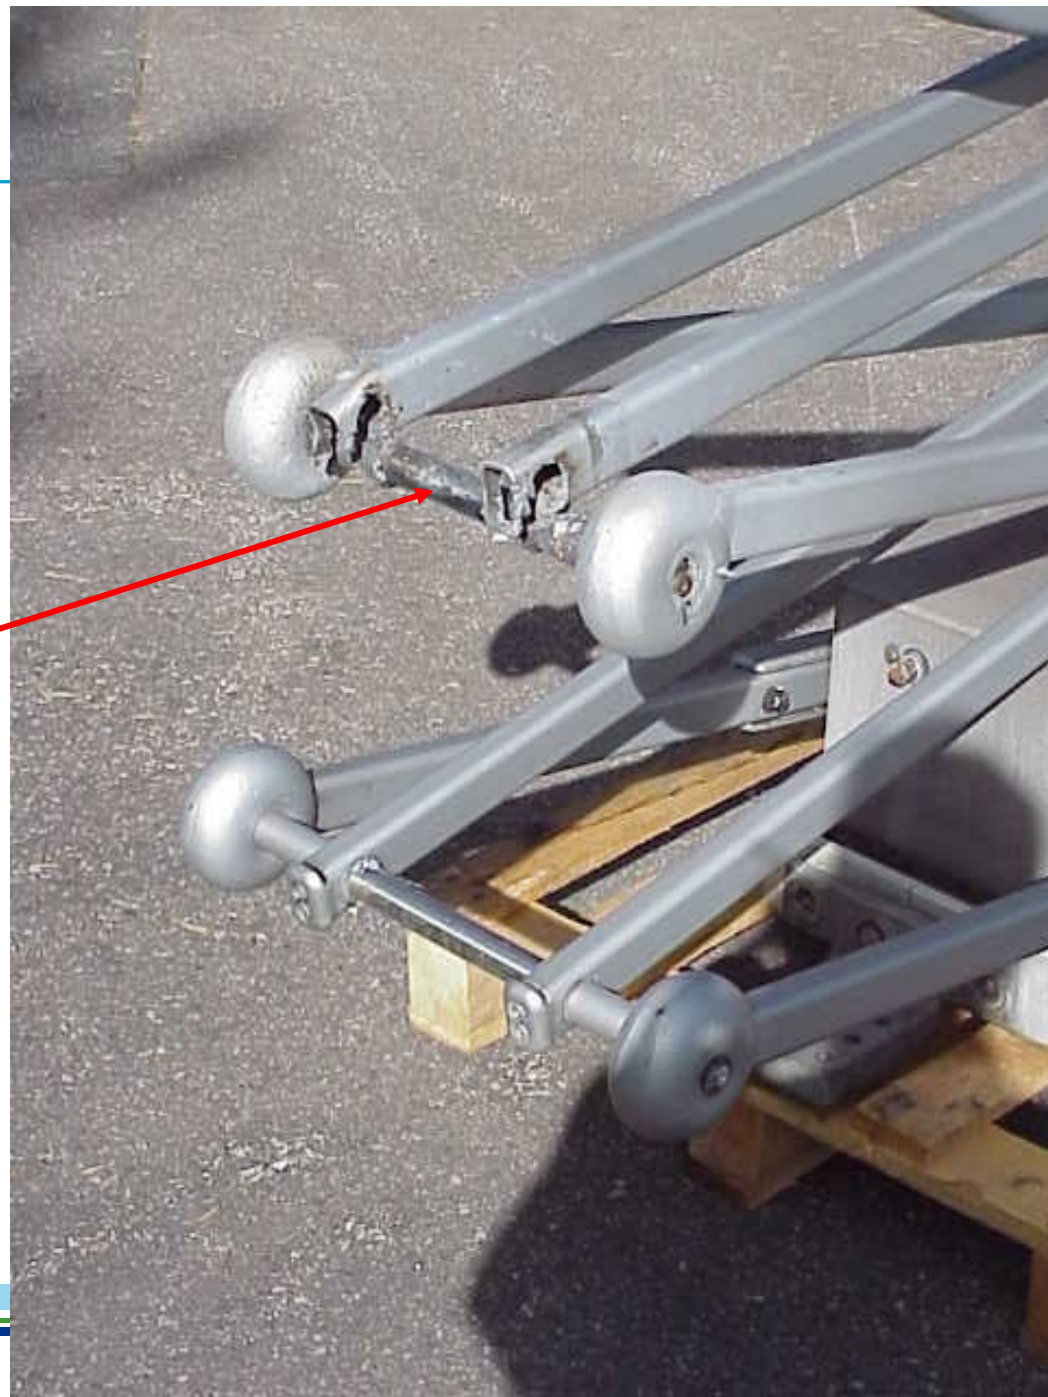
## Damaged Disconnect

Overheating

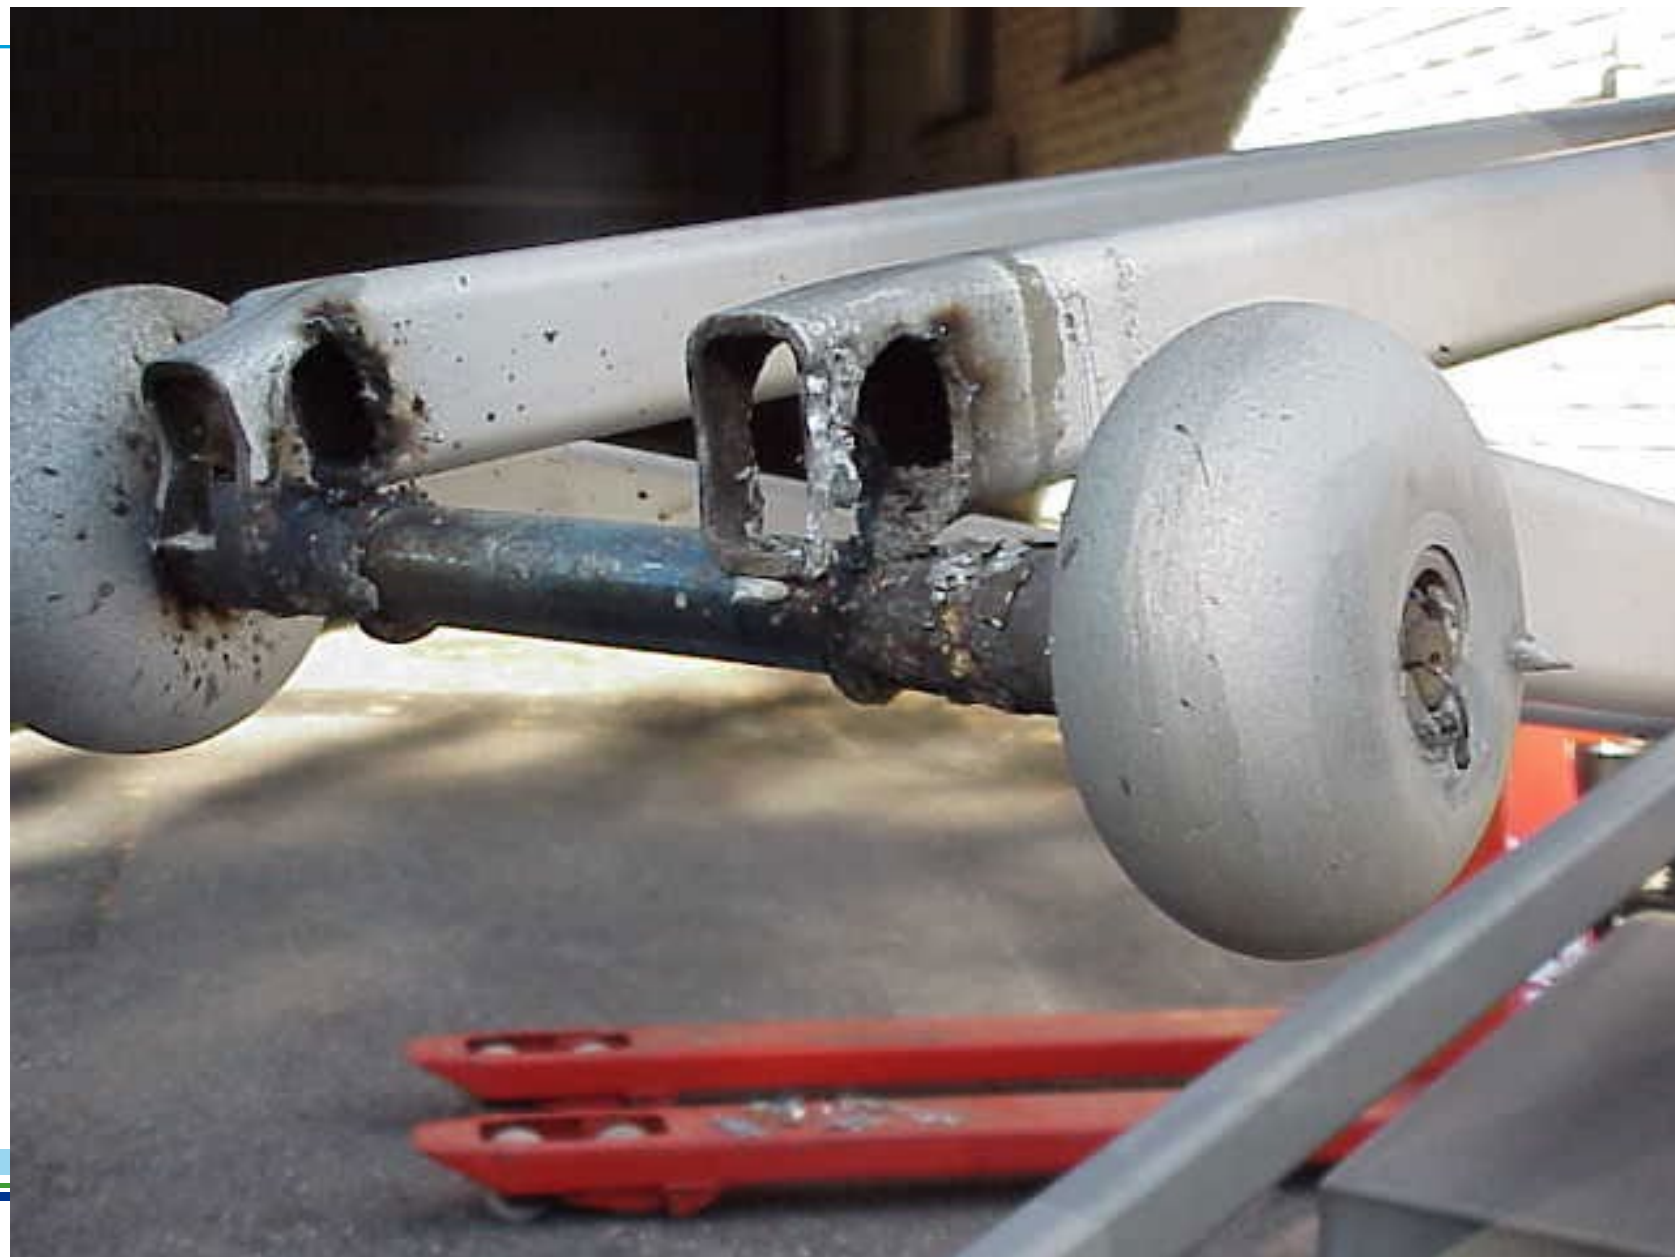
## Damaged Disconnect
