# The 1983 and 2003 Blackouts in Sweden

Nordic Electric Power System Seminar Chalmers  
November 09, 2023

Daniel Karlsson, DNV  
Adjunct Professor, Chalmers

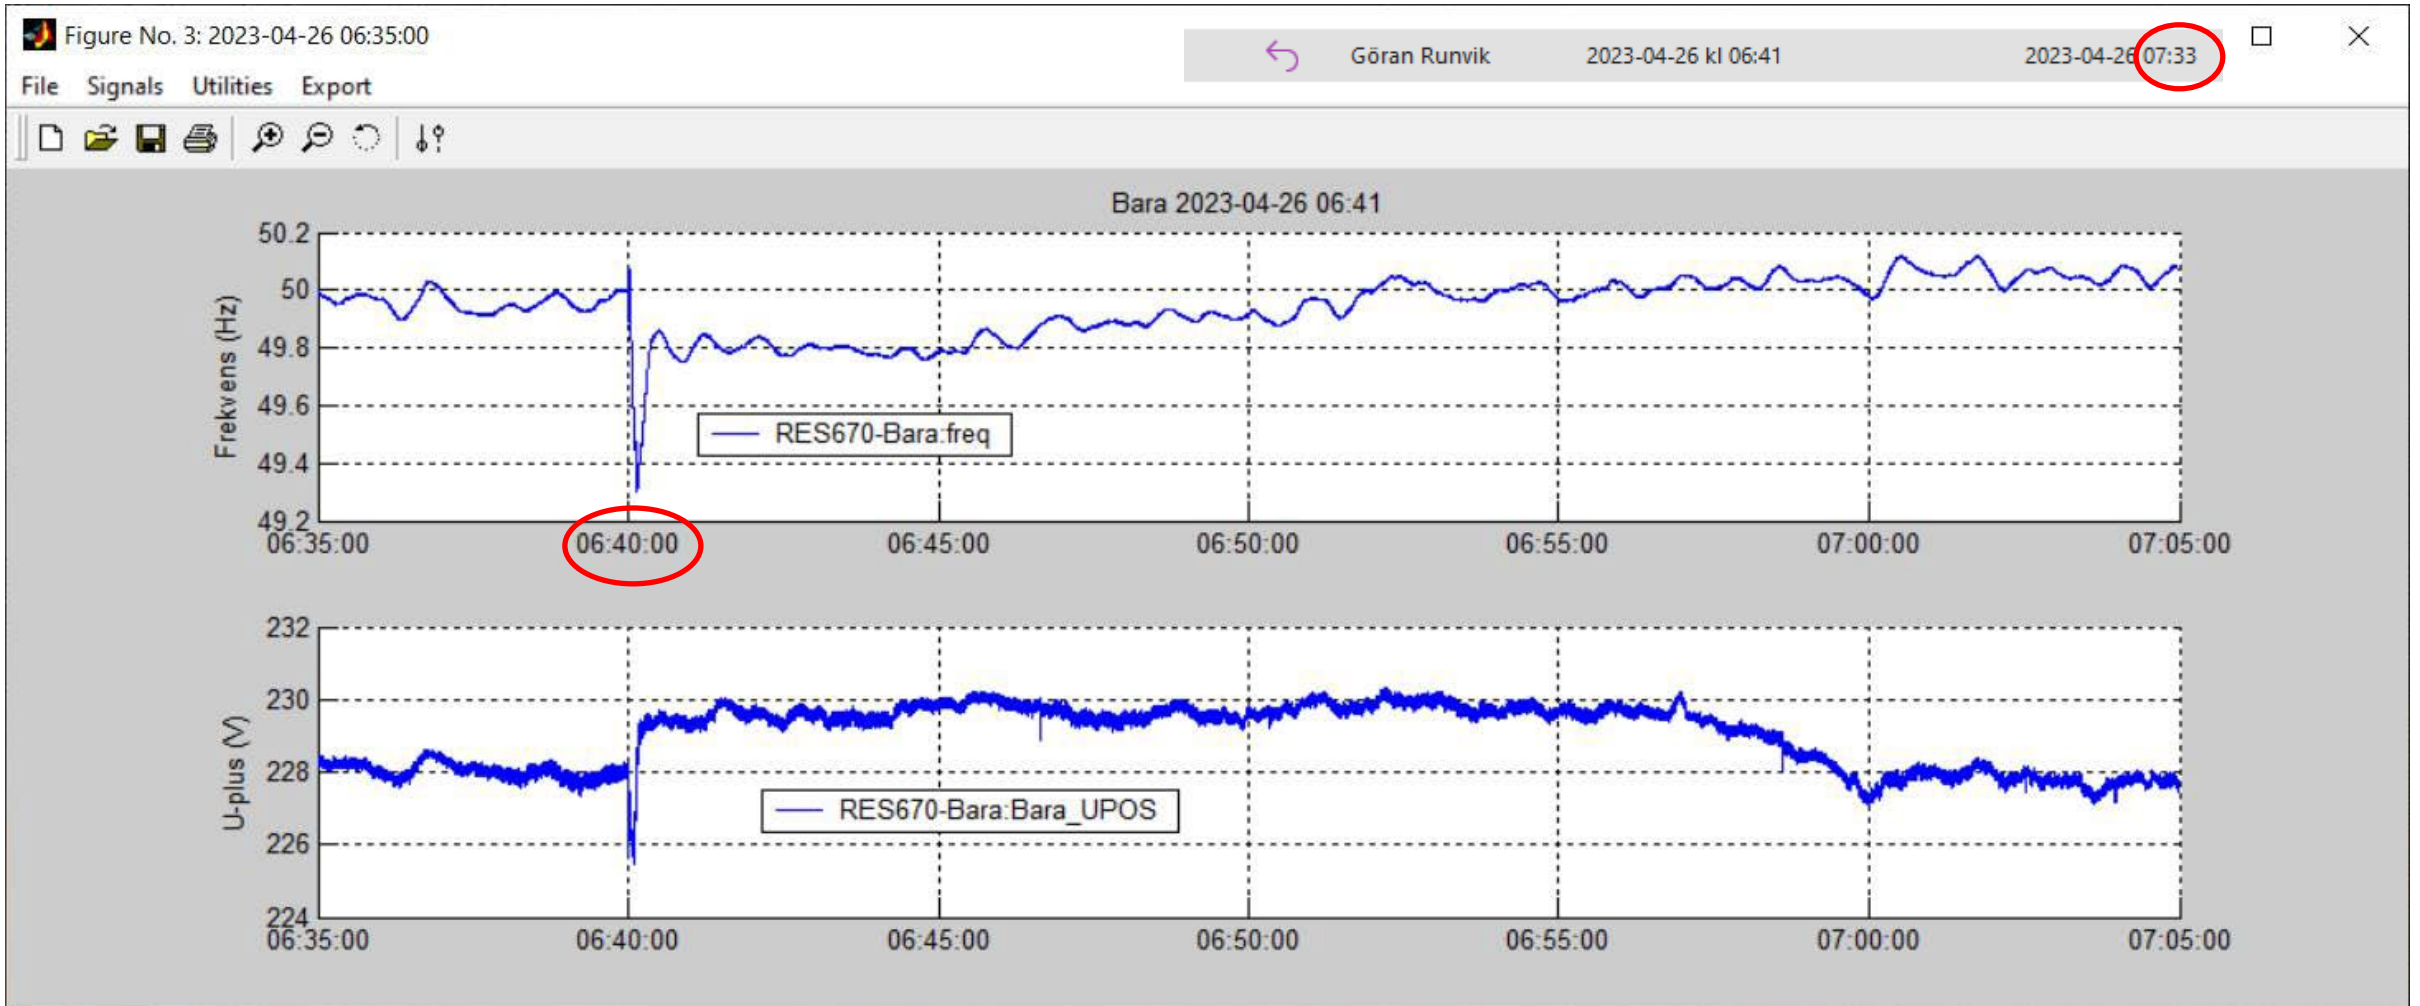
# Hagby 220 kV fault – First notice – A PMU outside Malmö (600 km from Hagby)

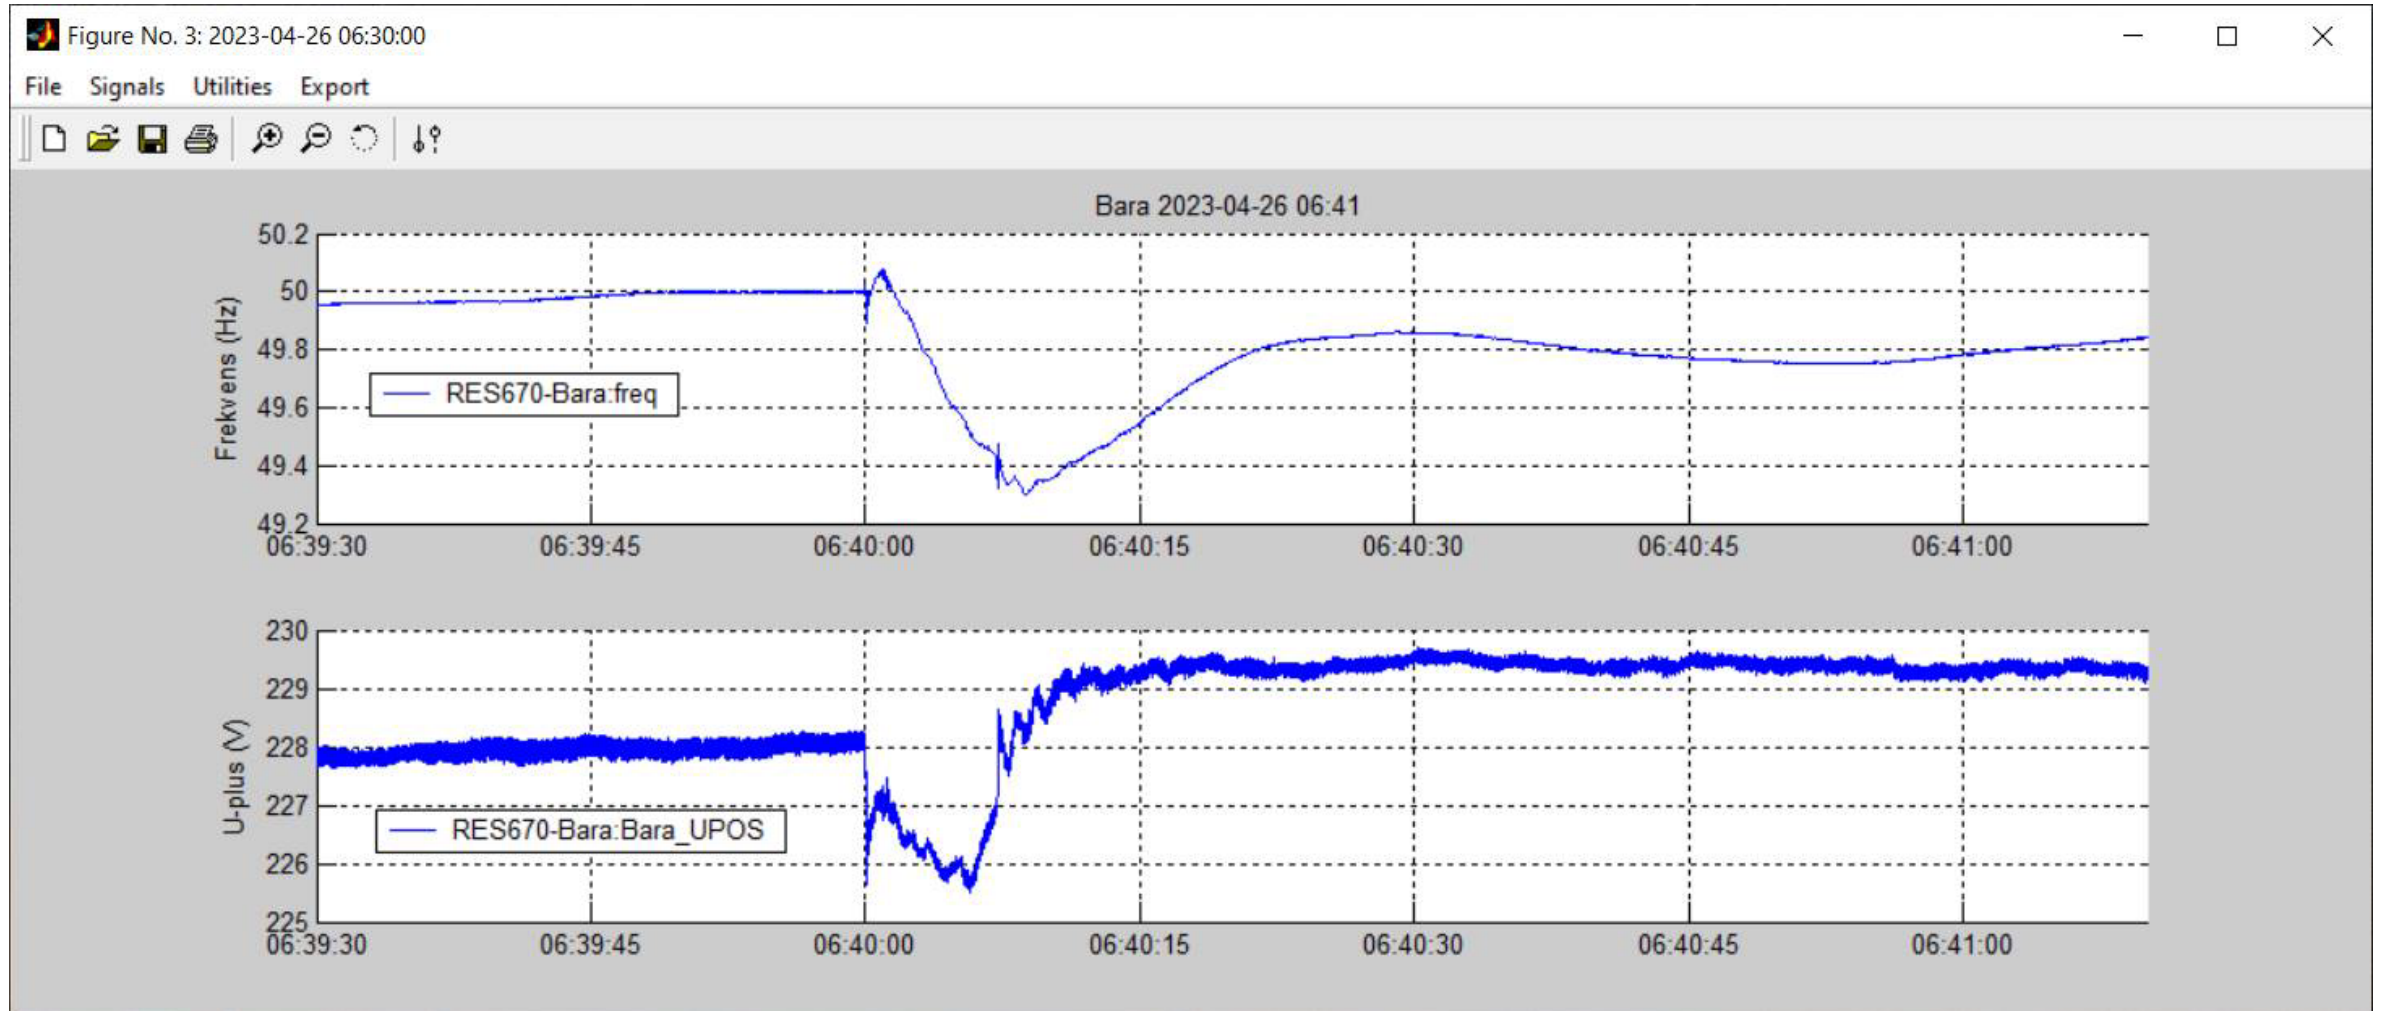
# Hagby 220 kV fault – First notice – A closer look

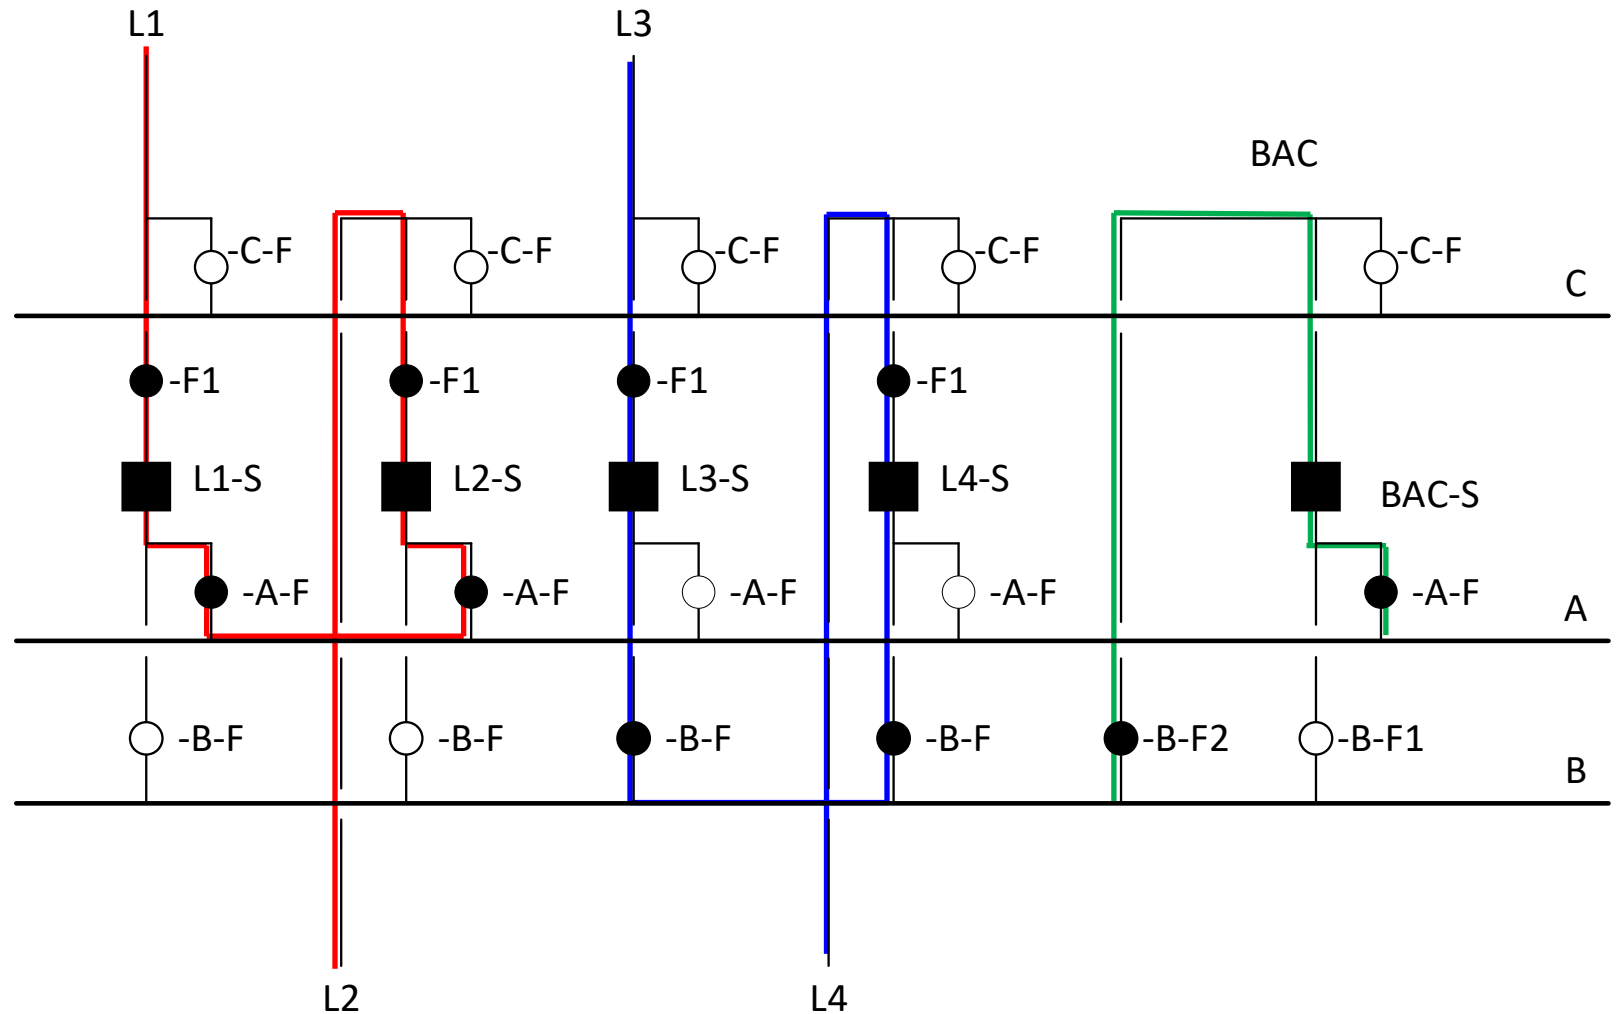
# The Hamra substation design – and normal operation switching state

- ABC switchgear
- Combined backup and sectionalizing breaker
- One line from North to the A-bus and one to the B-bus, and similar for the lines southward
  - A busbar fault with successful bus-split will keep one north-south connection alive

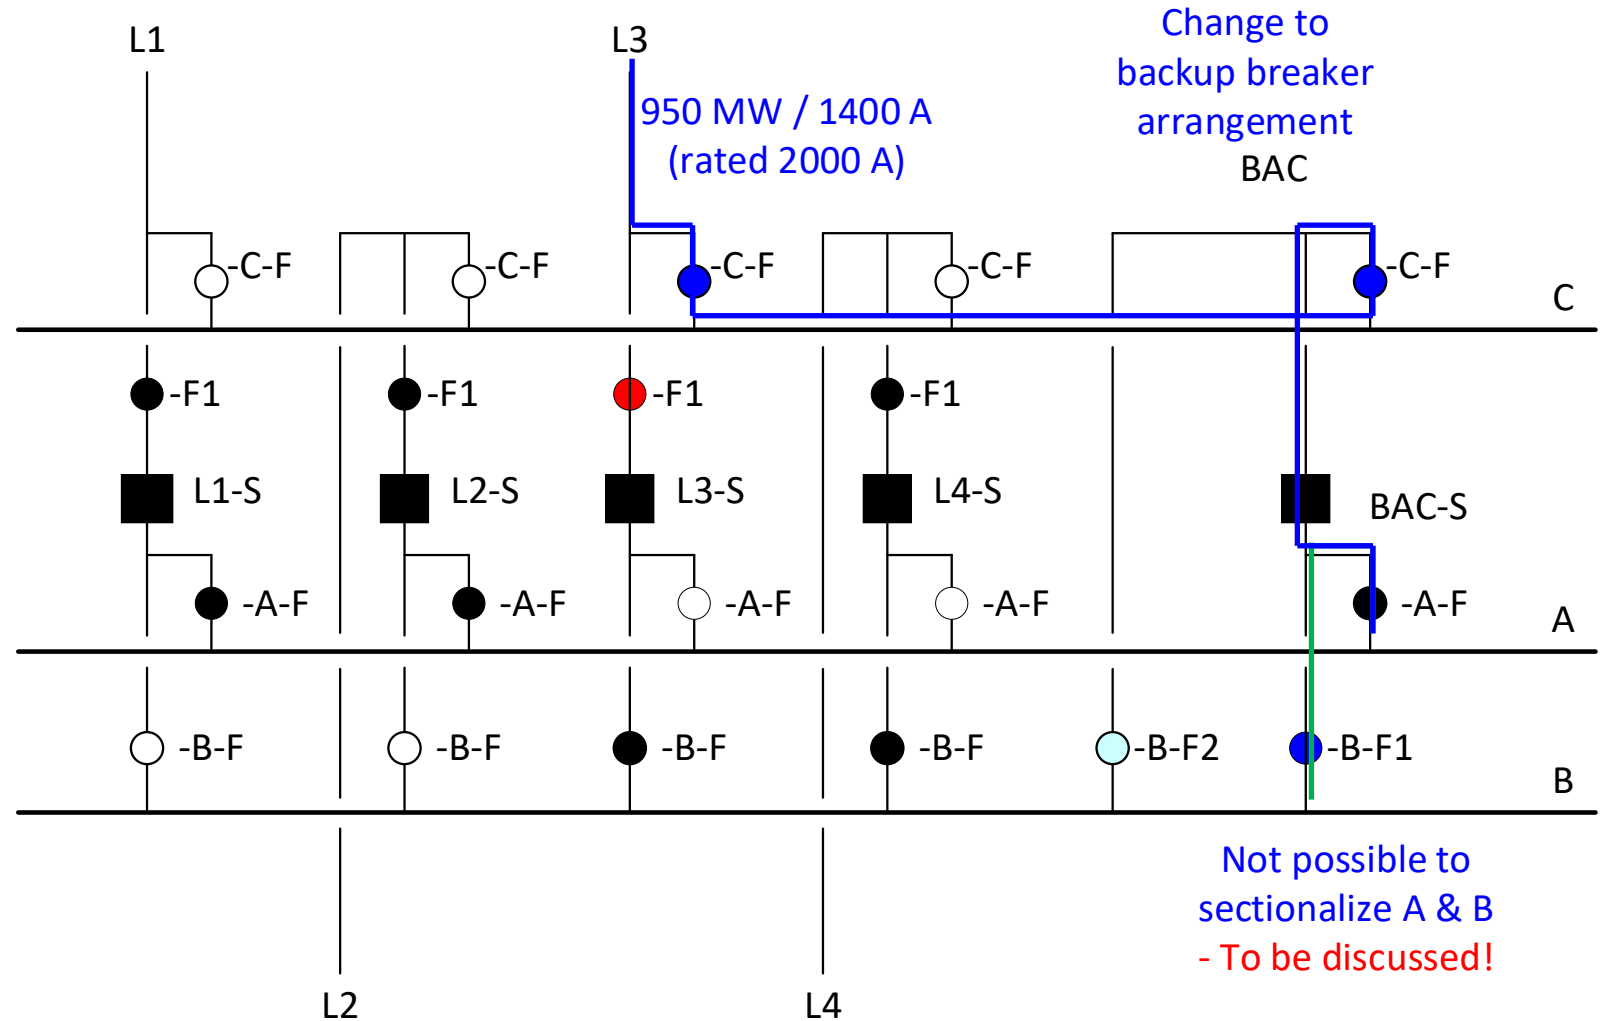
# Switching sequence to use the backup breaker for line L3

- Connect bus A and bus B via the two disconnectors
  - No sectionalizing possibility!
- Connect L3 to bus A via the bus C and BAC-S

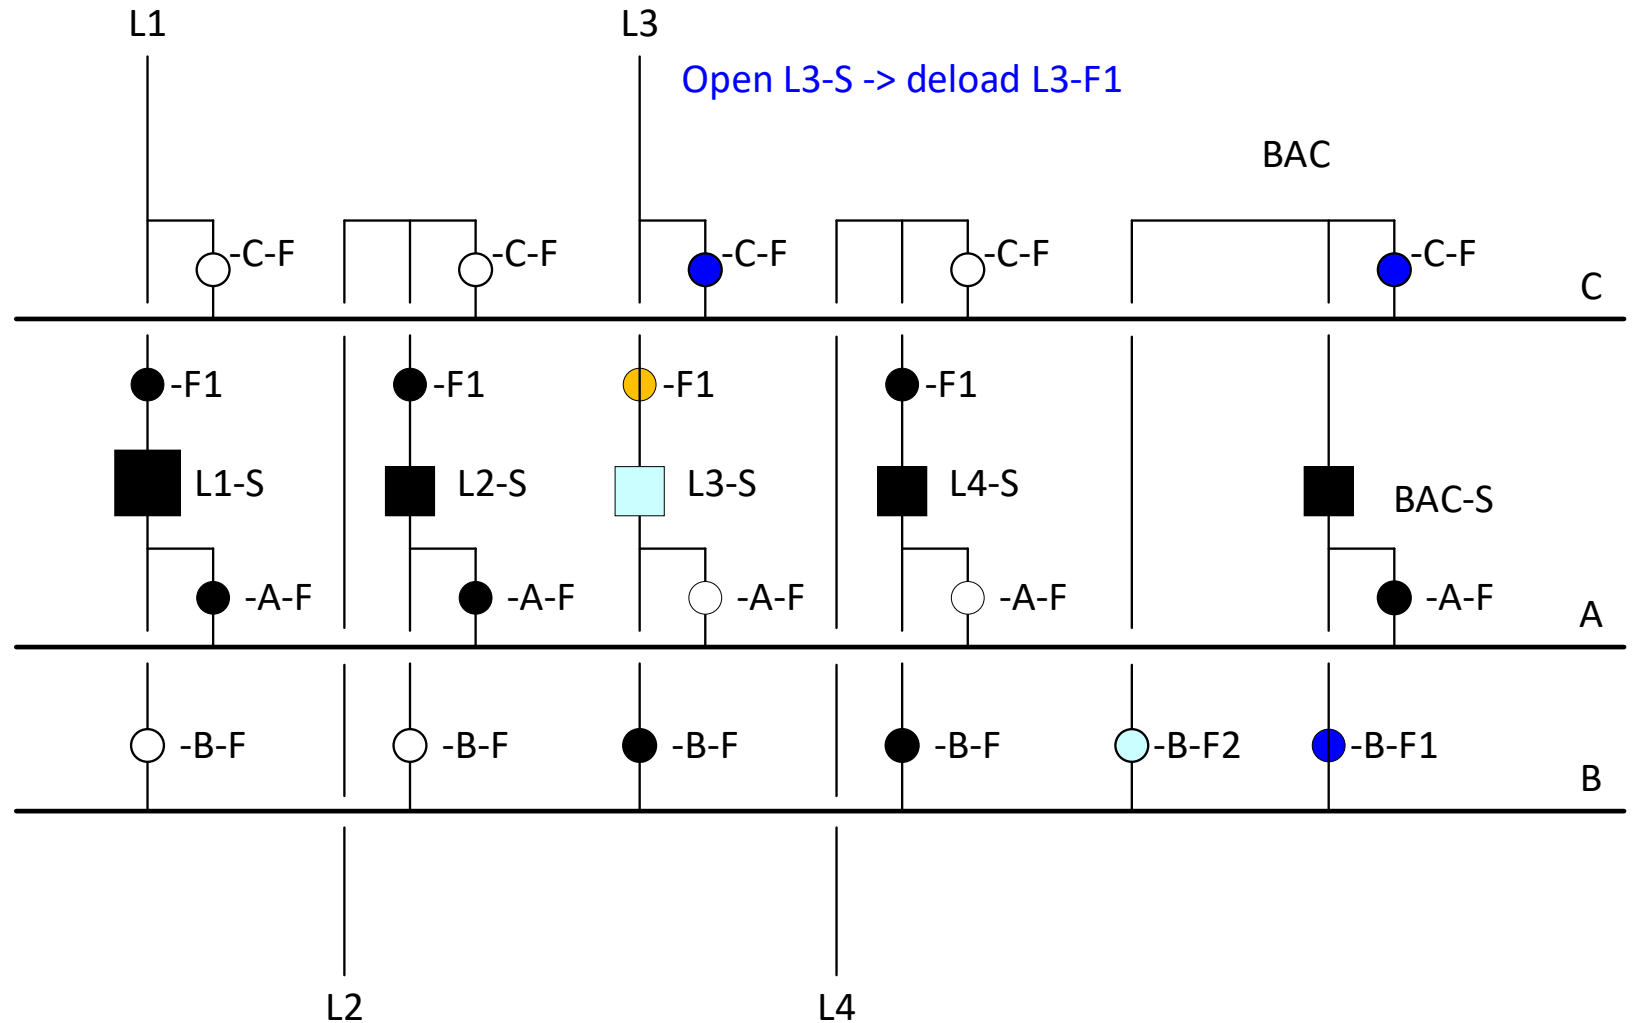
## Opening breaker L3-S and deloading the disconnector

- At the end of the switching sequence:
  - L3-S was opened and L3-F1 was totally deloaded (no current)
  - Everything is nice and stable ...

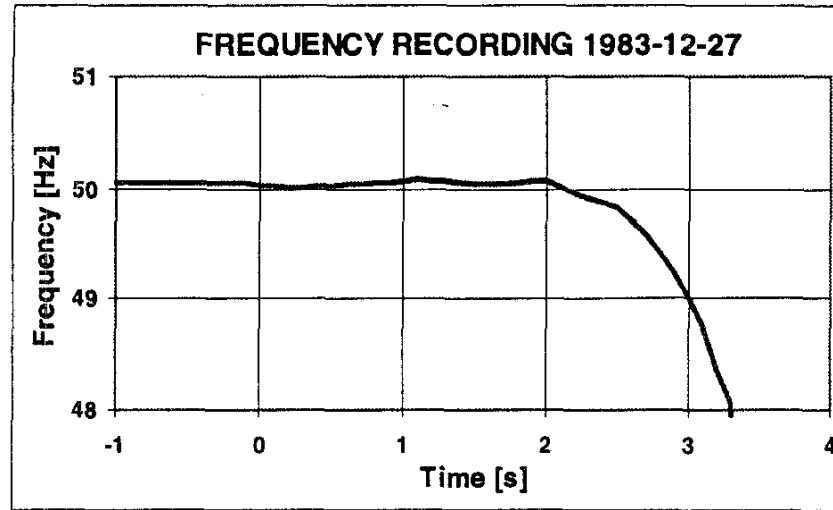
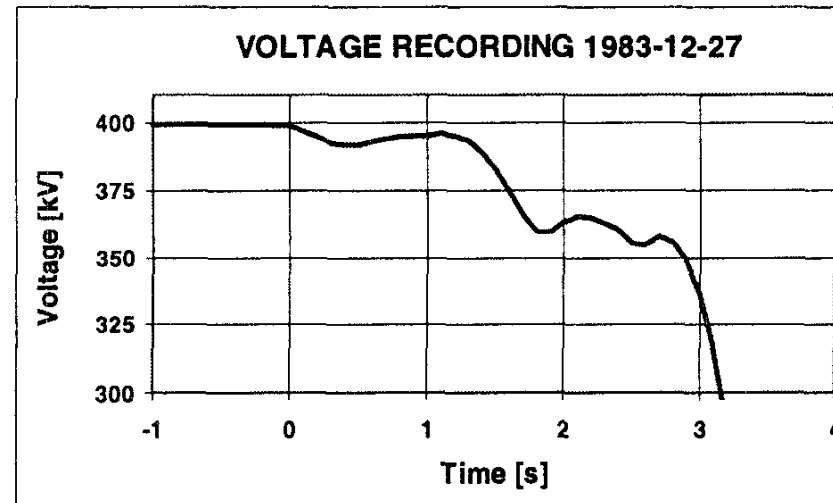
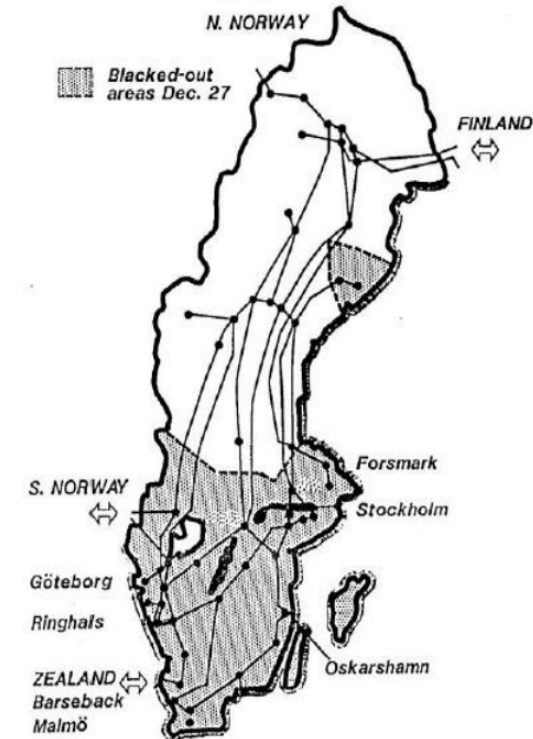
## 12:58 – Blackout in Southern Sweden

- Stable transmission system voltage and frequency in the very south, close to Barsebäck – See recordings, immediately before the breakdown
- 53 seconds after the earth-fault
  - Distance protection zone 3 finally started to trip lines
- Voltage instability was discovered in Sweden ...
- The role of zone 3 in transmission grids to be discussed/investigated
- **Ref:** [Operational experience of load shedding and new requirements on frequency relays | IET Conference Publication | IEEE Xplore](#)

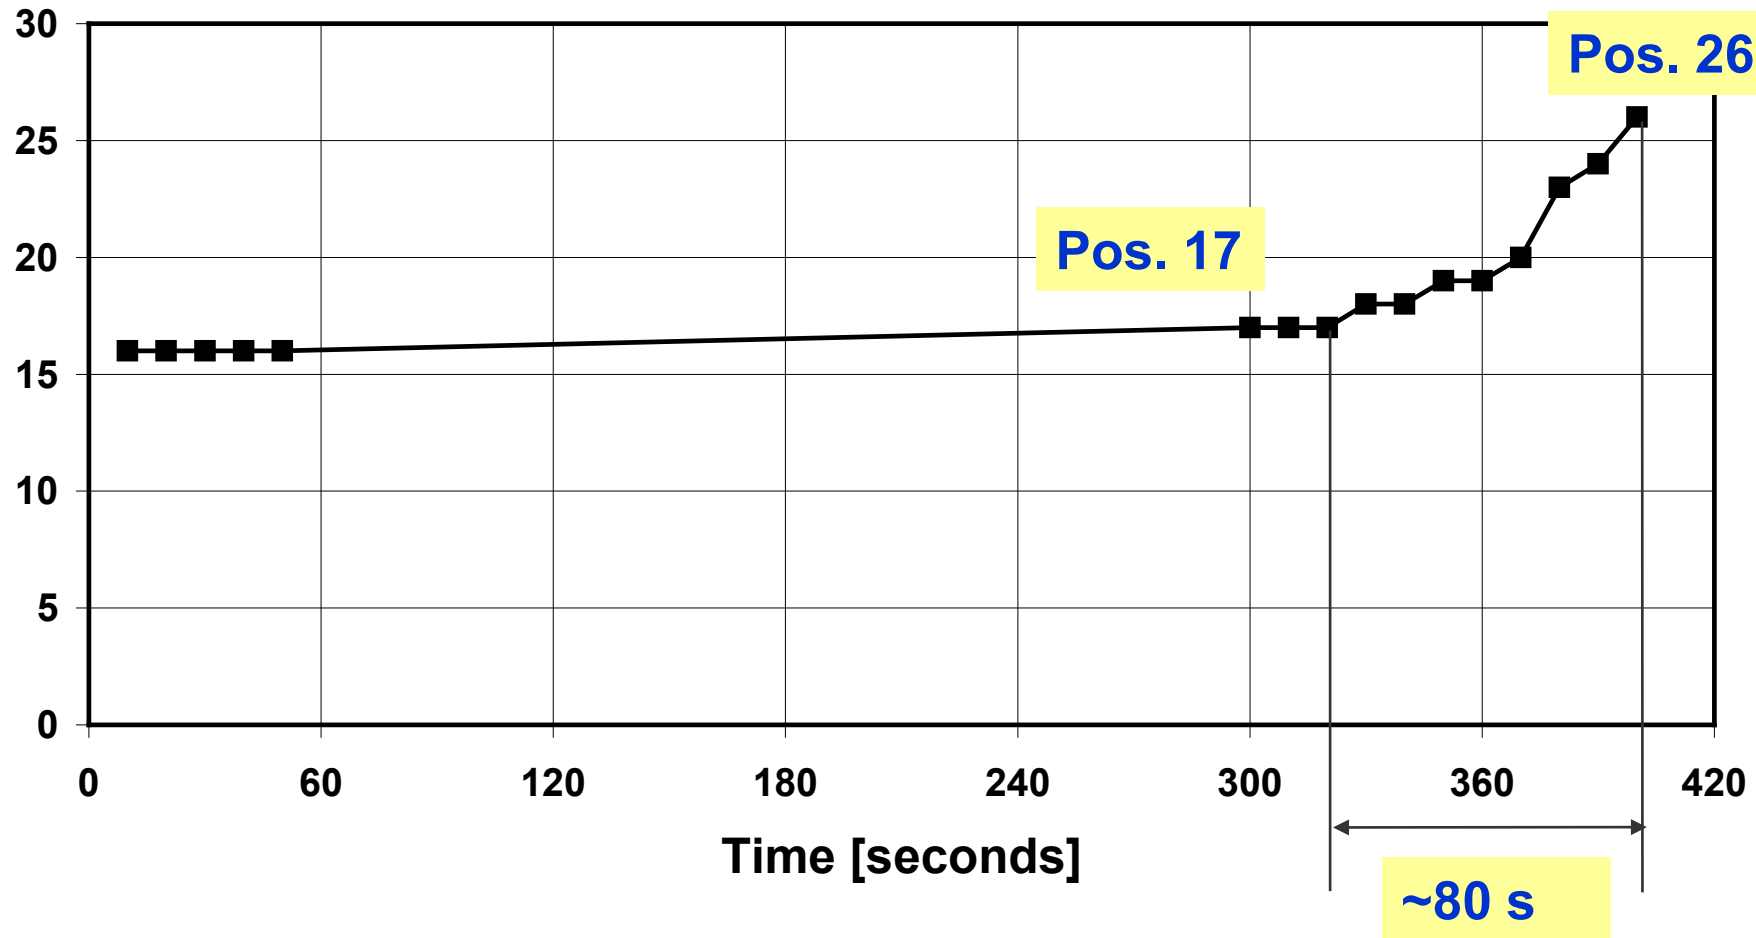
## TC-position Simpevarp

# Tap Changer 400/130 kV South East Sweden
